Manhole Inspection Summary

Manhole # S31A__021MH

Insp Date: **12/27/07 10:53 AM**

Location Address: **401 DRUID HILL AVE**

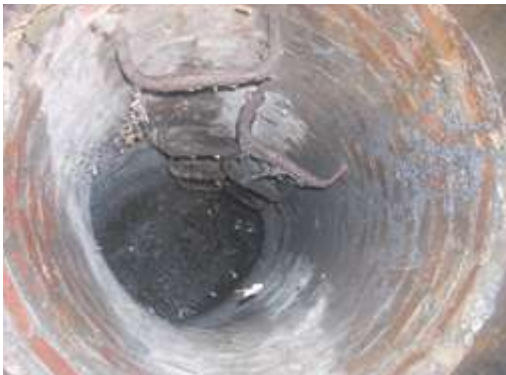
Defect 1

Count: **7** Missing: **0** ☒ **Corroded**

CORRODED STEPS

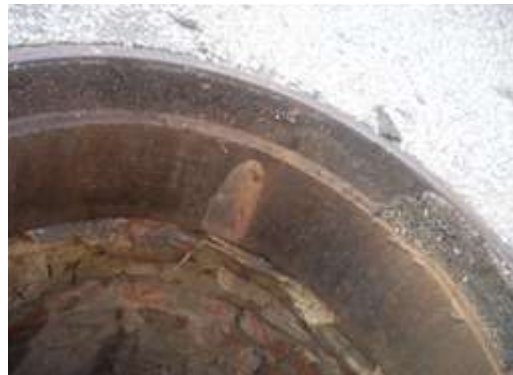
Defect 3

Condition: ☐ Sound ☐ Cracked ☐ Root Intrusion ☐ Loose Brick ☒ **Deteriorated**

CHIMNEY DETERIORATION

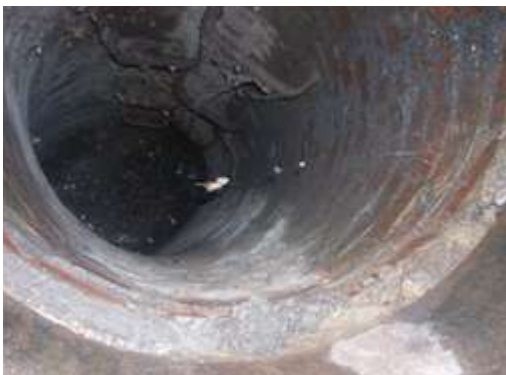
Defect 2

Offset: **2** (in.)

FRAME OFFSET

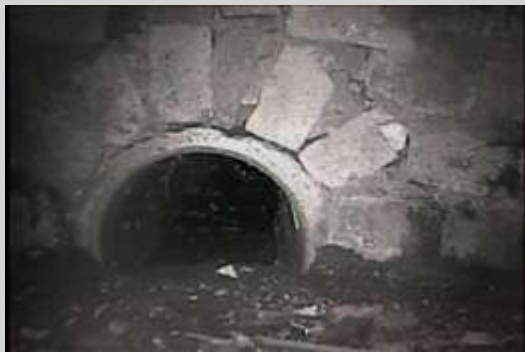
12 O'Clock Outflow

Deposits: ☐ None ☐ Mud ☐ Sludge ☒ **Debris** ☐ Grease

Silt Depth: **3** (in.) Deposits Extent: **Heavy**
